Campus Accessibility for the Disabled: Fixing the Footpaths on Campus

For
Rex Wolf
Architect
Facility Services

March 15, 2010

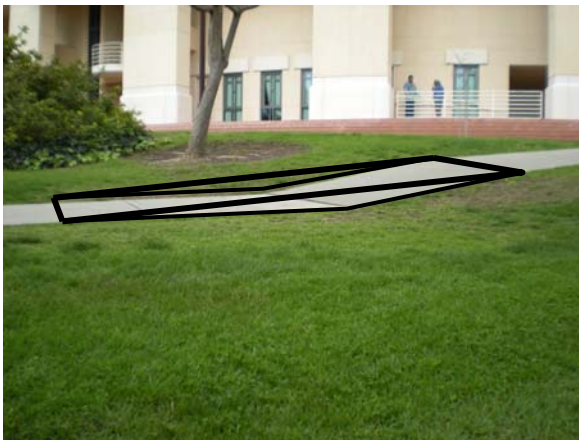
It is evident from Figure 7.2.A below that the slope at the top is too steep for a

Figure 7.2.A: The projected location of the new walkway contains a steadier, smaller slope than the original.

disabled person to access safely. The markings made indicate the area where the new path would be. As you can see, the slope of the new path is significantly smaller than the original, allowing a smoother transition to the building entrance from the street. Since the project takes place on the original path, there will be no significant damage to the surrounding environment.

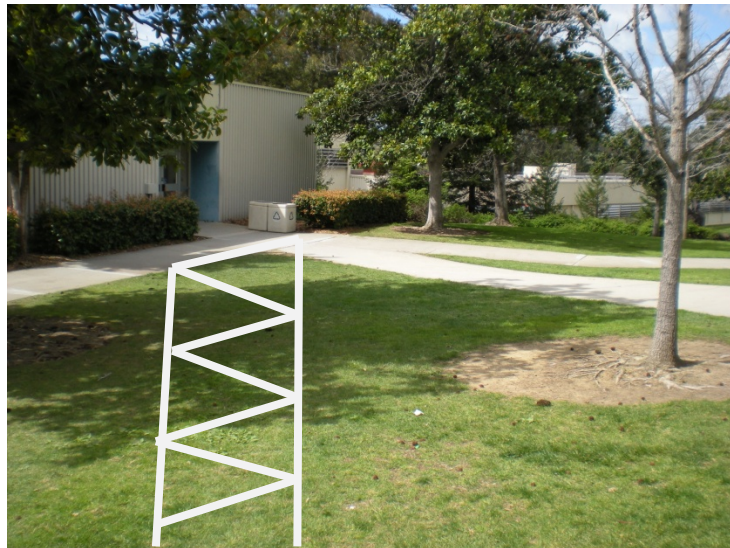
The area where the option to relocate the pathway is valid includes the upper entrance of Math and Science, shown below in Figure 7.2.B:

The new pathway contains a leveler, more constant slope than the original, allowing the transition to the entrance to be much smoother. During its construction, the original walkway will still be accessible. Relocating the pathway allows a new opportunity to implement new natural features where the original pathway existed, such as grass or a new tree. What can be determined regarding cost is that the relocation method is more expensive than the “rebuild and fill” method since it requires a change in the entire pathway.

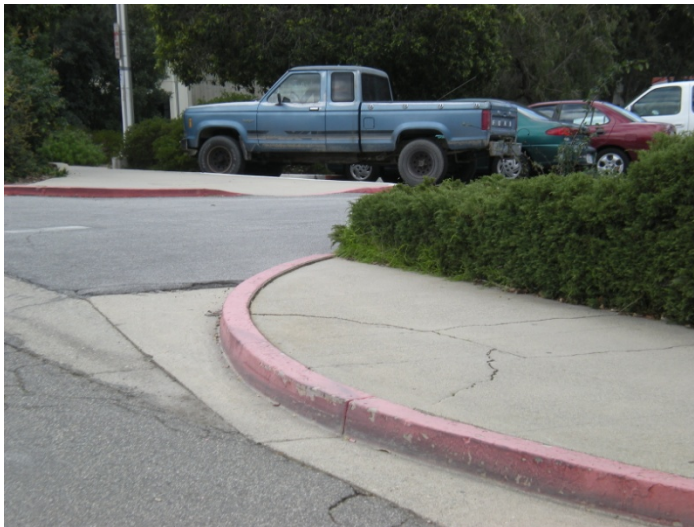
the disabled. The sidewalks on the H4 parking lot surface have areas with and without curb ramps as seen in the figure to the left. We recommend that a curb ramp eventually be installed; in the mean time, we suggest providing appropriate signage that an ADA approved route lies right across the street which will allow pedestrians to cross North Perimeter road safely. Normally, a

perpendicular curb ramp would suffice because the path of direction for pedestrians is limited to one direction only. However, the awkward shape of the sidewalk requires an unconventional fix. A built-up curb ramp would obstruct cars exiting the parking lot because the entrance and exit is so narrow. Therefore, a diagonal curb ramp would provide the best functionality for pedestrians and motor vehicles.

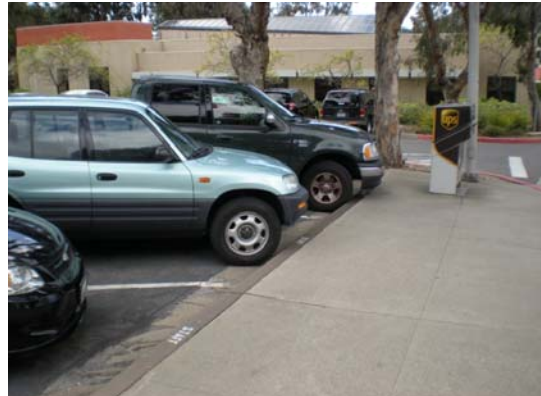
Furthermore, the sidewalk displayed in Figure 9.1.B on the right portrays a sidewalk that is accessible to pedestrians because of a diagonal curb ramp at the top of the sidewalk; however, a few hundred feet down the footpath, a person in a wheelchair would struggle to find a safe way to get off the sidewalk to get to the police department or corporation administration building below. This additional problem with the H4 parking lot pathway circuit furthers the need for appropriate signage to be installed at the intersection of North Perimeter Rd and Village Dr. The curb ramp problem can be seen more clearly in the picture on the bottom-right of the page. The UPS drop-off box, light pole, and curb parking for emergency vehicles makes installing a curb ramp extremely difficult. We believe the problem can be remedied by replacing the two lower parking spaces with a disability parking spot in one space and a built-up curb ramp in the other. A built-up curb ramp is the best option because the construction would only involve the step of building the asphalt up to the curb rather than having to demolish part of the sidewalk so one of the other curb ramps can be installed. The fix would make the lower half of the H4 parking lot completely accessible.

Figure 9.1.B: Although a person can get to this point in a wheelchair, there is no way for the person to get down off the sidewalk.

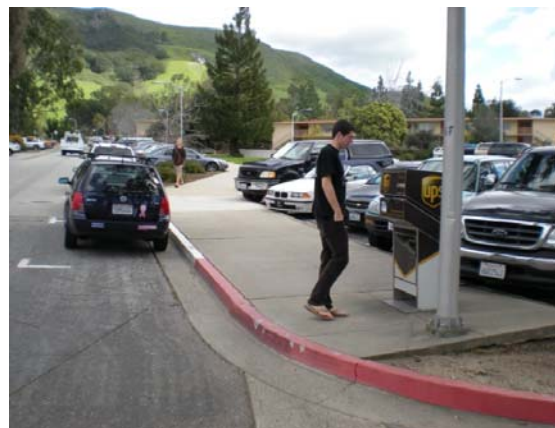
Figure 9.1.C: There are many obstructions that prevent the correct implementation of a curb ramp.

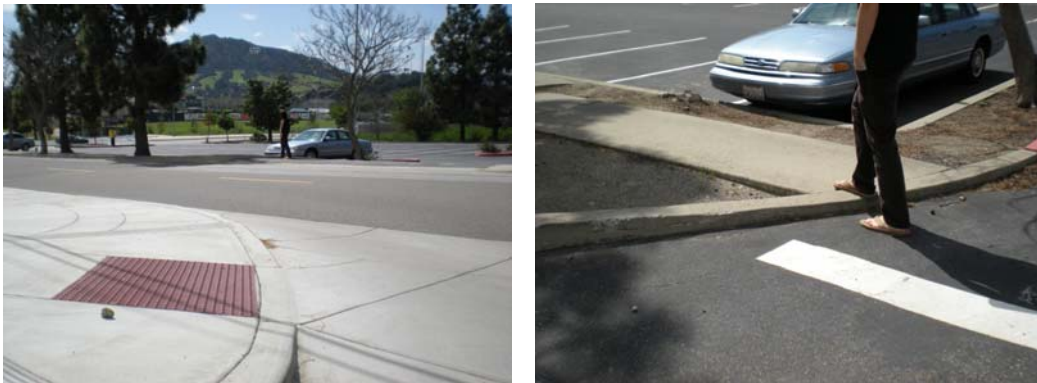
The footpath we inspected takes pedestrians to and from Poly Canyon Village to the Bagget Stadium (baseball fields). Although the pathway was recently developed so it complies with the ADAAG, the sidewalk across Via Carta does not have curb ramps. Because the crosswalk ends in the picture on the left and students use the route daily to get to class, there needs to be a curb ramp (with additional concrete around the areas of dirt) installed on the sidewalk shown on the right in Figure 9.1.D to make the back road to Bagget Stadium and, ultimately, the campus accessible to the disabled. A diagonal curb ramp would work better than all other types of curb ramps because the crosswalk runs diagonal to the flow of vehicle traffic rather than perpendicular.

Figure 9.1.D: The sidewalk on the other sidewalk lacks a corresponding curb ramp.

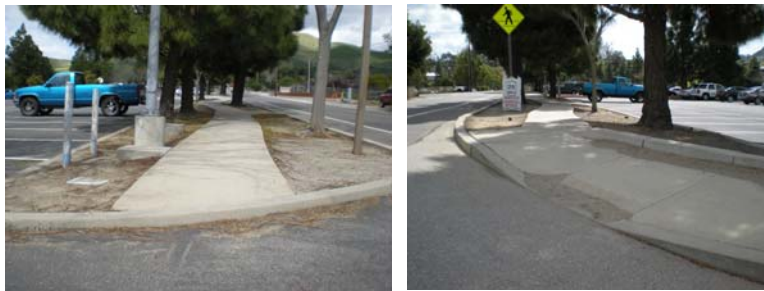
Figure 9.1.E: The sidewalk has a curb ramp leading up on to it but not off.

Keeping in mind the cost and feasibility of fixing the sidewalks on Via Carta, we propose that an accessible route be made using both sides of Via Carta to reduce the amount of curb ramps needed. Our proposition would require only three curb ramps and one crosswalk to be installed as

opposed to eight curb ramps if the accessible sidewalk was made to go only down the west side of Via Carta. The first curb ramp would be installed at the bottom of the sidewalk as shown in the left picture in Figure 9.1.E above. We recommend a diagonal curb ramp because the radius of the curb does not allow enough space to implement a sufficient perpendicular or parallel curb ramp. The second and third curb ramp

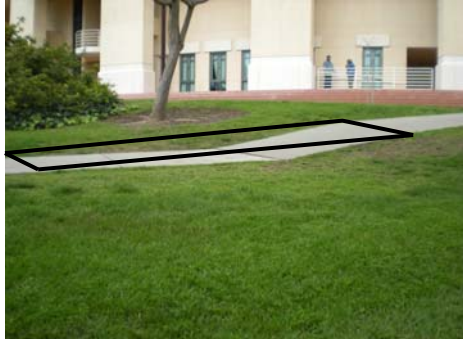
Figure 9.1.G: The new recommended path is highlighted in black.

the disabled, especially students coming from areas like Mustang Village. The small footpath has a major slope violation at the top shown in Figure 9.1.G above. The issue can be easily remedied by using the “rebuild and fill” technique as discussed in section 7.2 Walkway Specifications. The walkway leading up to the portion of the footpath in Figure 9.1.G would also have to be leveled and repaved to fix the cross-slope and roughness of the walking surface. Although this may be one of the more costly propositions, it is the easiest fix and cheaper than relocating the path because of the amount of landscaping that would need to be done. It would also improve the aesthetics of the west part of campus and make the business building completely accessible to the handicapped.

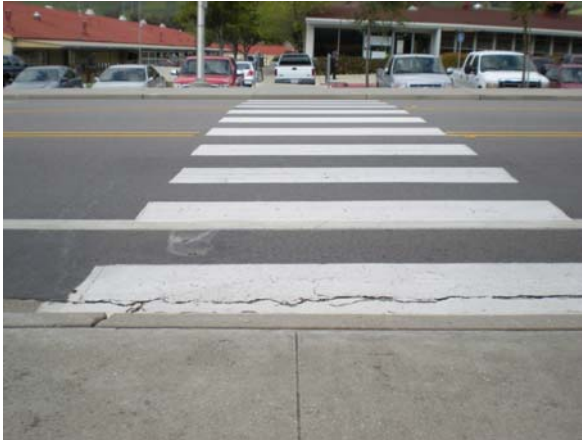
The current transition plan indicates that curb ramps already exist at the intersection featured in the figure below. The obvious correction is to unmark the

Figure 9.2.A: The crosswalk does not have curb ramps on either side.

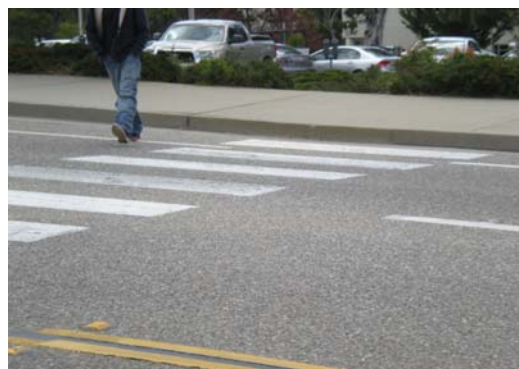
At the top of North Perimeter, the transition plan displays the existence of a curb ramp in the crosswalk featured below in Figure 9.2.B. A perpendicular ramp at this crosswalk would be more beneficial than the one proposed in 9.2.1, because a topographical map of Cal Poly indicates the next crosswalk north of the one featured would have pedestrians on a slope steeper than 1:20--a slope unsafe for the handicapped. The next crosswalk that is south of North Perimeter Rd and Mountain Lane can be quite an inconvenience for pedestrians to use,

Figure 9.2.B: The crosswalk has a curb ramp on the side not shown.

especially if their final destination is north of the crosswalk. Furthermore, a curb ramp, interestingly enough, does exist on the side of the crosswalk not presented in the picture above. This strengthens our cause to believe a curb ramp needs to be installed; our reason being if a curb ramp leads to a road or a sidewalk, the road or sidewalk should lead to another accessible pathway or building--not a dead-end. Therefore, we recommend a perpendicular curb ramp be installed at the intersection of North Perimeter and Mountain Lane and also be listed as a priority in the new transition plan.

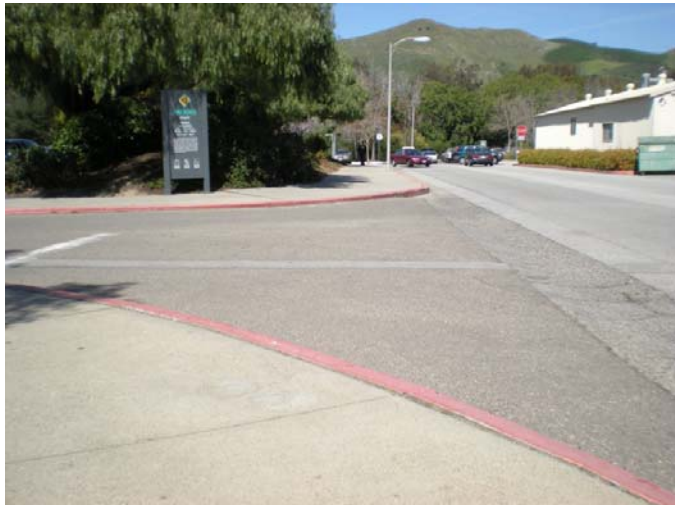
Figure 9.2.C: The Cal Poly transition campus map indicates curb ramps should be at both sidewalks.

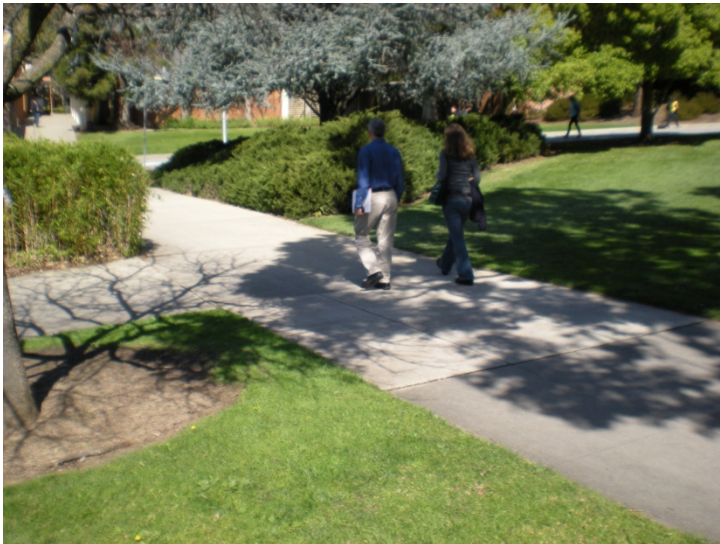
The data we took of the footpath on the northeast corner of the Science Building showed that the transition plan was erroneous on their analysis on which parts of the path were too steep. We found that the pathway only exceeded a slope of 1:20 on the section behind where the people are walking, shown in the figure below. Our discovery is very important because that means the ADA approved that the pathway shown below in Figure 9.3.A is accessible to the disabled from North Perimeter Drive. Therefore, the Science Building is virtually accessible from this area of campus. The inconvenience of having to walk around to get to some of the classes located at the top of the Science Building is irrelevant in comparison to some of the greater accessibility issues present on campus.

Figure 9.3.A: The pathways on the left half of the picture are ADA compliant.
Source: Authors

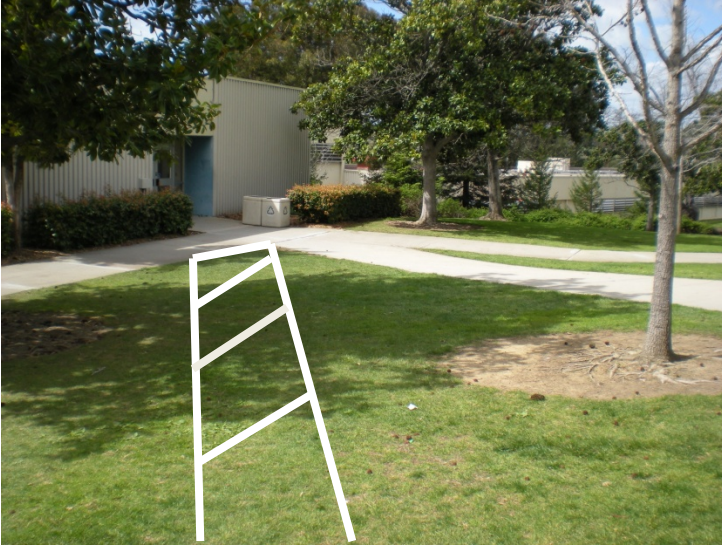
The Math and Science entrance featured in Figure 9.3.B on the next page has multiple paths of entries. However, the entrance was a source of the 2009 complaint

received from the United States Department of Education. The transition plan labels the middle path questionable as to whether it passes ADA Accessibility Guidelines or not. The path looks deceptively safe for the disabled; however, after taking multiple measurements of the footpath, we found that the middle pathway has a small section where the slope was too steep. The rebuild and fill

method initially looks to be the cheapest way to fix the steepness of the slope. To address the aesthetics of such a project, the amount of dirt that would have to be added, not only to the pathway but to the surrounding the sidewalk so the grass around would be flush with the footpath, would exceed the appropriate cost to fix this problem. Therefore, relocating the middle footpath would be most rational when looking at cost. Relocation would also make the middle path still accessible while the new footpath is being constructed. Afterwards, the middle path can be removed and a new landscape feature can be installed such as a bench or a tree.
