Campus Accessibility for the Disabled: Fixing the Footpaths on Campus

For
Rex Wolf
Architect
Facility Services

March 15, 2010

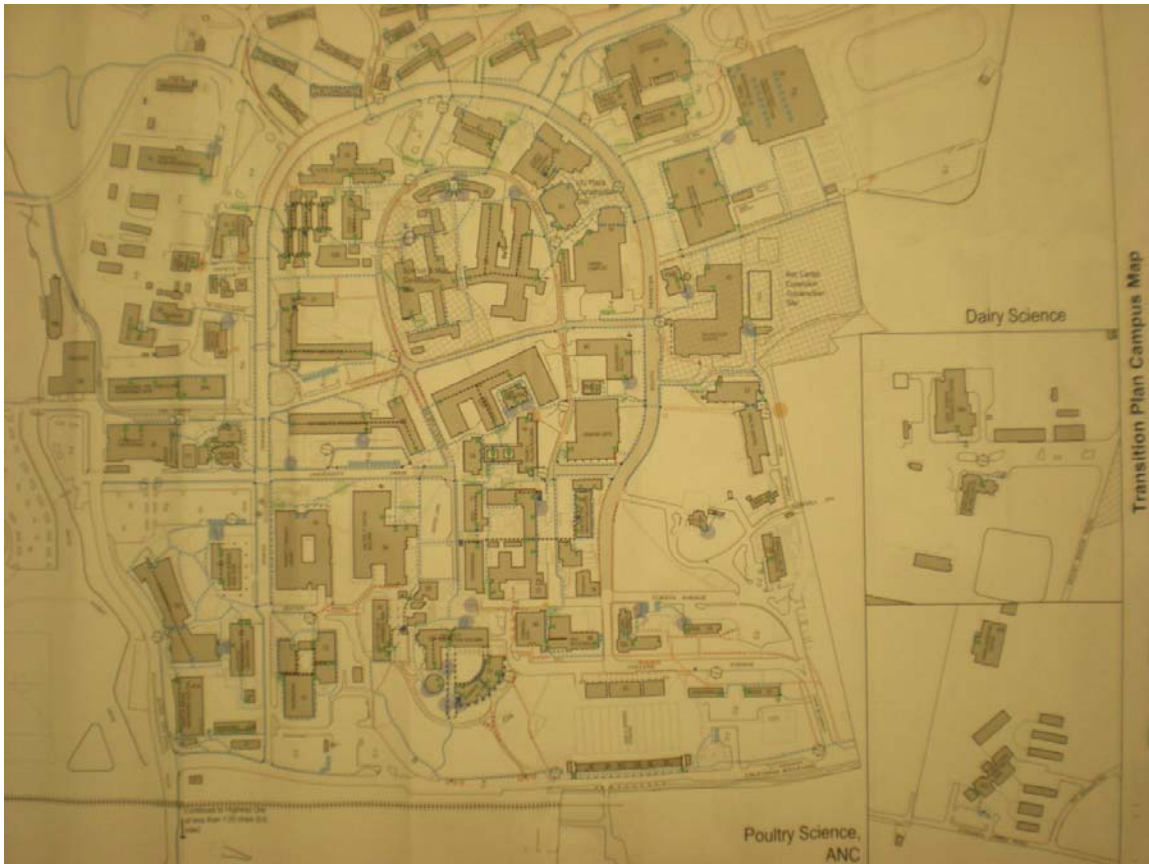
Figure 2.0.A: Transition plan campus map color codes all pedestrian pathways by slope.

The Disability Resource Center instructs people with handicaps that restrict mobility to use the transition campus map as guide to safely navigate the person through campus. Their recommendation proves to be extremely problematic as we discovered that the transition map contained erroneous data. Not only do the flaws present a liability issue to Cal Poly, but they also completely jeopardize the new transition plan if not corrected. Therefore, to help progress the finalization of the new transition plan and ensure the validity of the data being used currently, we will present the following:

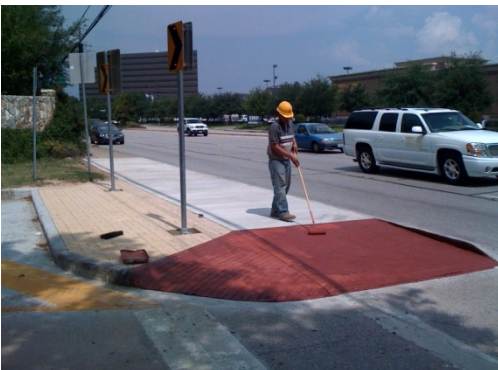
Many of the dead-end pathways on campus contain curb ramps leading up to a sidewalk, but there are not any curb ramps leading down off the sidewalk. Indicated disability paths that would lead to an area or pathway that does not meet building code requirements are also dead-end pathways. Figure 3.1.A, on the left, is one example of a dead-end pathway. The current design of the sidewalk would obviously create quite a nuisance and possibly a safety risk for the disabled. A picture
